# Television and Radio Service Bulletin

September 23, 1958

VIKING PMP 331

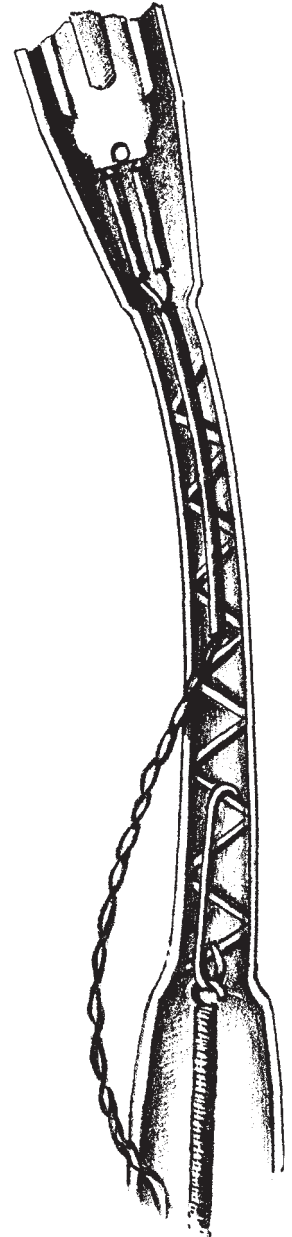
On some of the above units, the plastic pins supporting the pick-up arm springs were found to be broken in transit.

These units may be easily repaired by adding a wire hook from the end of the spring to one of the diagonal cross members in the pick-up arm. A paper clip cut in half with a hook formed on each end will serve the purpose.

The hook should be placed in the proper cross member to give 8 - 9 grams pick-up weight.
