# Television and Radio Service Bulletin

May 11, 1960

## MODEL PMP 423 IN HIGH LINE AREAS

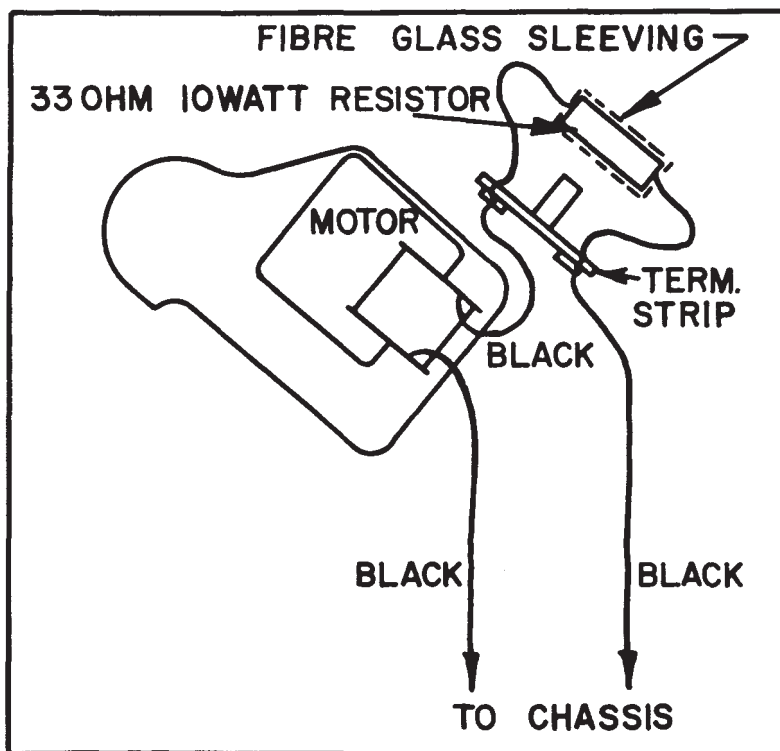
When the above model is operated for several hours at high line voltages (125 - 130 volts) the 25L6GT tube may become gassy with resultant failure of the selenium rectifier.

This condition may be corrected by adding a 33 ohm 10 watt resistor in series with the motor and tube heater as noted in the sketch below.

If you should encounter this problem in your area, we would recommend the above modification. Resistors are available free of charge upon request. Please refer to this bulletin when requesting resistors.
