Television and Radio Service Bulletin

December 22, 1958

RCS 372 and RCS 373 TUNERS

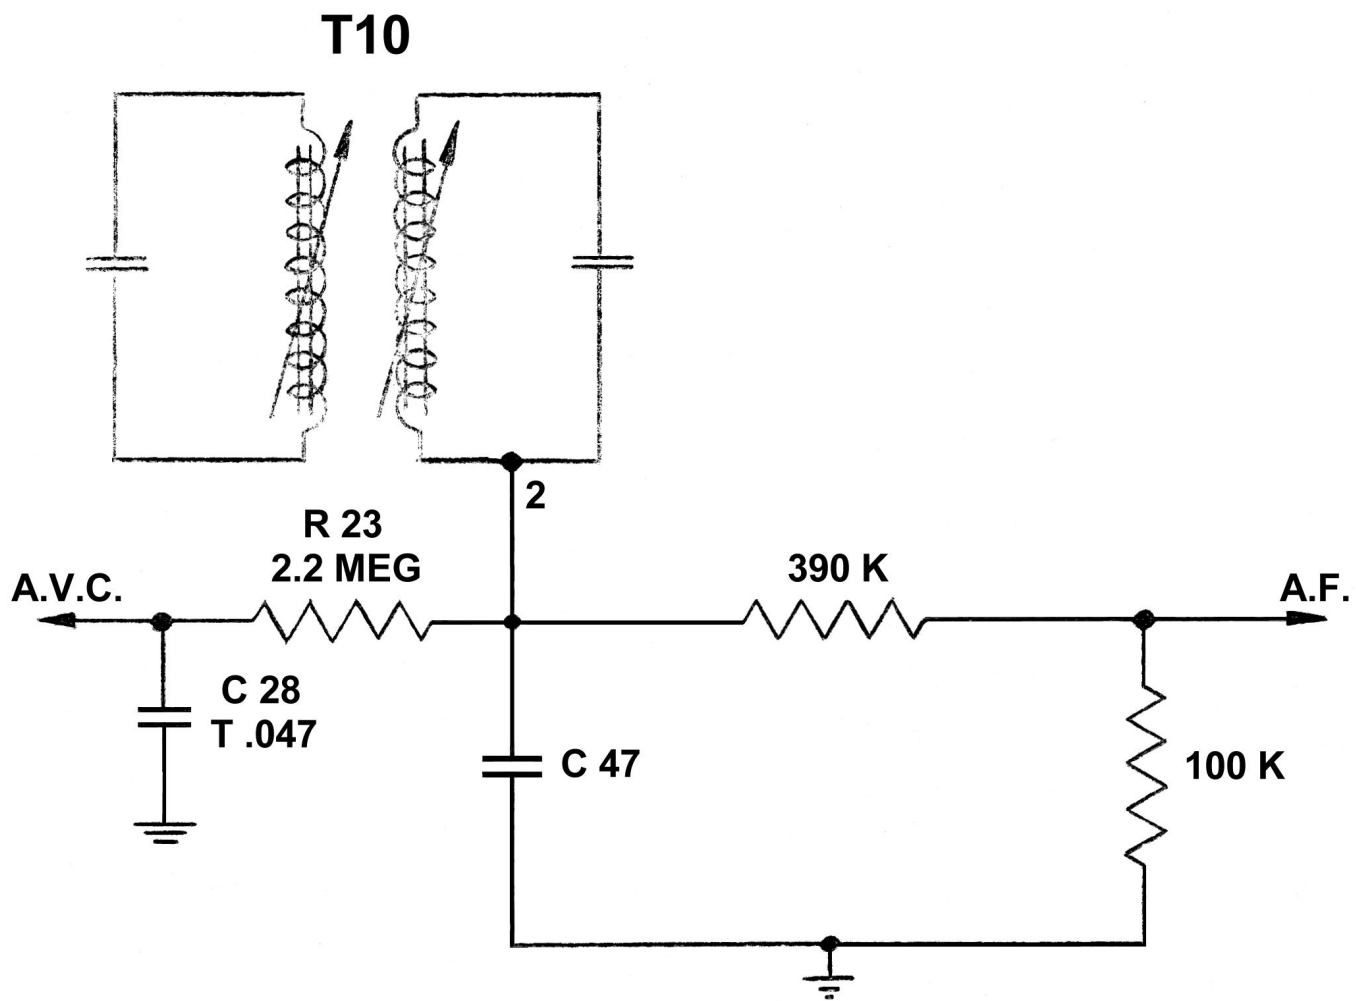
TUNER MODIFICATION FOR A.M. DISTORTION ON LOCAL STATIONS

- (a) Distortion may occur on peaks when a local station is using excessive levels of modulation. This condition will depend on the operation of the local station and will not be apparent in all areas. Where distortion does occur, the tuner may be modified as shown on the attached diagram. The I.F. transformers T2 and T10 should be realigned after this modification is completed. Refer to the RCS 372 service manual for circuit diagram and alignment instructions.
- (b) As an alternative, a 470K half watt resistor may be added in series with the green lead from the junction of R 22 and R 23 to the selector switch. A one lug terminal strip secured by the rear gang mounting screw should be added. Cut the green lead at the added terminal strip and connect the 470K resistor between the added strip and the selector switch.
