Sparton Radio Service Manual

BULLETIN No. 10-B
Effective November 1, 1930

Service Data for Sparton Ensemble Model 235 Automatic Phonograph Mechanism

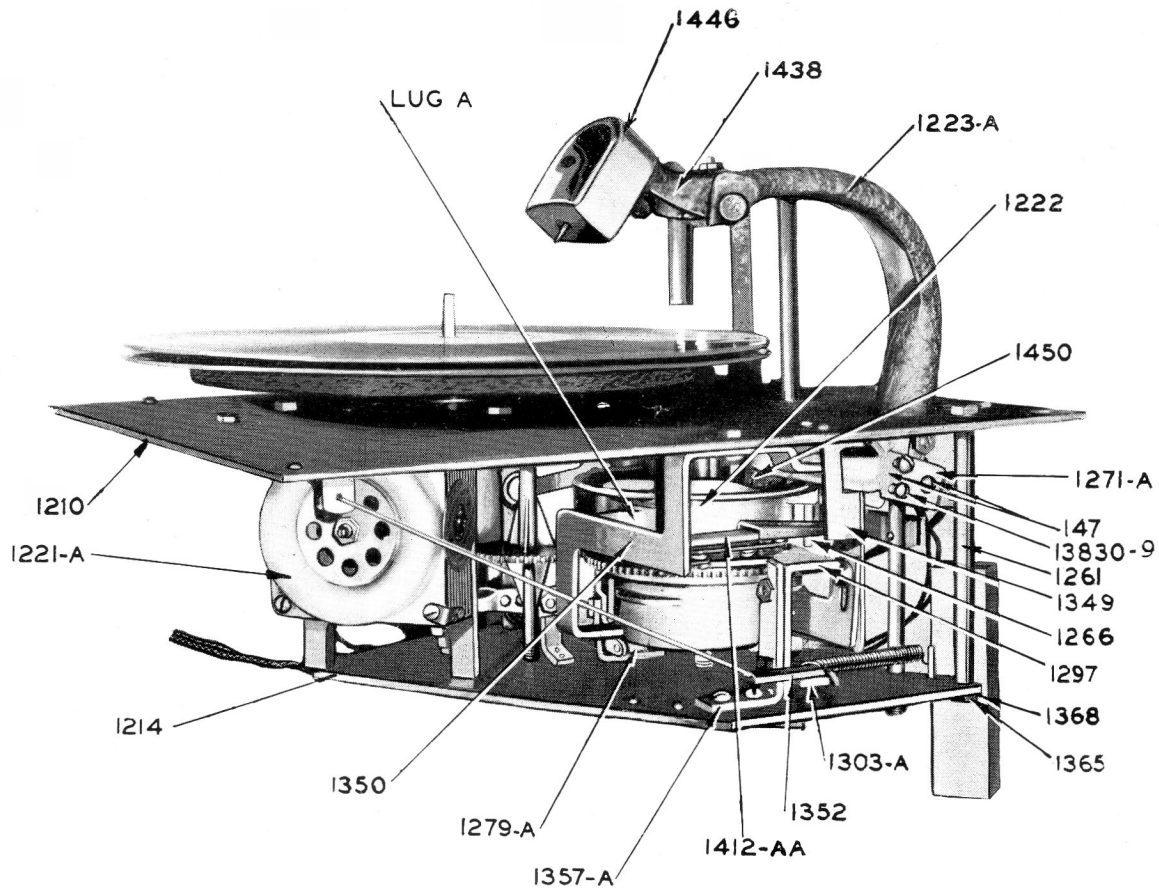
FIGURE A

TO MAKE STOP SWITCH CUT OFF AT THE PROPER PLACE, which is just before Pick-up strikes Turntable, use screws which hold Stop Switch No. 1412-A (Figure A) by loosening or tightening front screw and holdout screw where Stop Switch attaches to top plate. On early models do this by adjusting Follower Arm.

5. Cutout switch (Part No. 1412-AA, Figure A) will not shut off?

Height of tone arm not properly adjusted. This is adjusted through follow-arm (Part No.

1271-A). Adjust pickup higher and set motor cutout switch lower.

TO ADJUST MECHANISM SO PICKUP COMES DOWN IN THE PROPER PLACE, adjust Screws No. 147 (Figure A) in and out as required. To keep the front surface of Follow-Arm No. 127-A parallel use Screws No. 13830-5, adjusting them in or out.

Arm Pin No. 1450 (Figure A), making it tight in groove on top of Cam No. 1222 (Figure A). This can be adjusted through Follow-Arm No. 1271-A. It may be necessary in some cases to smooth the edges of the pin with a file.

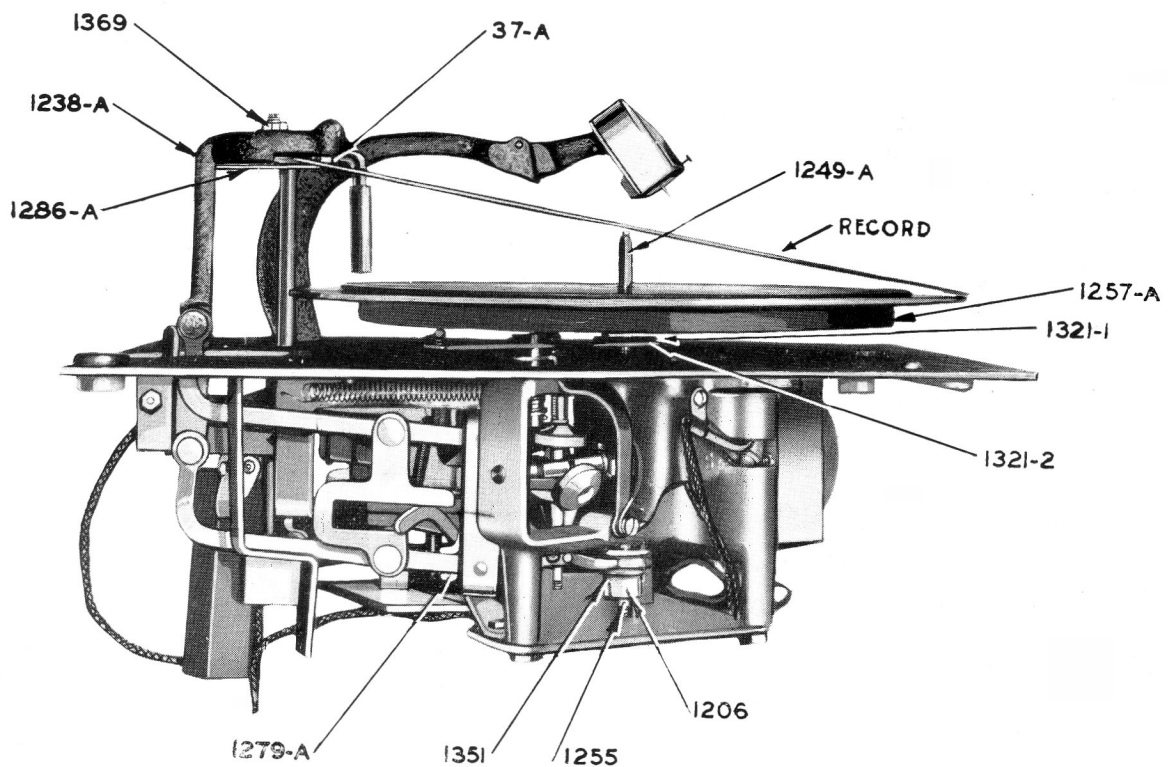
FIGURE B

TO PREVENT SCRATCHING OR MARKING OF RECORDS WHEN THEY ARE DISCARDED, be sure that Fibre Tip No. 1460 is in the end of Spindle No. 1249-A (Figure B). Also, it is necessary that the edges of Spindle No. 1249 are smooth so that it will not enlarge hole in record.

IF TWELVE INCH RECORDS FAIL TO DISCARD be sure that Guide Plate, which fastens to inside of cabinet in front of mechanism, is proper to prevent 12" records from sliding off the Disc No. 1286-A (Figure B) after record has been raised high enough to clear Spindle No. 1249-A. At the same time there must be plenty of clearance to allow record to be discarded.

(Figure B) UP AND DOWN, use set screw in Lever No. 1279-A (Figure B). This should be adjusted to the proper height so that 12" records just clear Spindle No. 1249-A when Discard Arm No. 1238-A is in its highest upward position.

TO ADJUST DISCARD DISC No. 1286-A (Figure B) loosen Nut No. 1369 and turn Discard Disc No. 1286-A to the proper height, then tighten Nut No. 1369. The proper distance for this adjustment is when Roller No. 37-A rests on record when Discard Arm No. 1238-A is in down position, there is just room for Disc No. 1286-A to pass under a normal size record.

TO ADJUST DISCARD ARM IN AND OUT adjust Discard Disc No. 1286-A (Figure B) so that it will just come down behind record in its lowest position, using screws which hold Roller Bracket No. 1472-A (Figure C) to Roller Arm No. 1471. Roller Arm may be bent to affect this change, when Roller Arm has no adjustment.

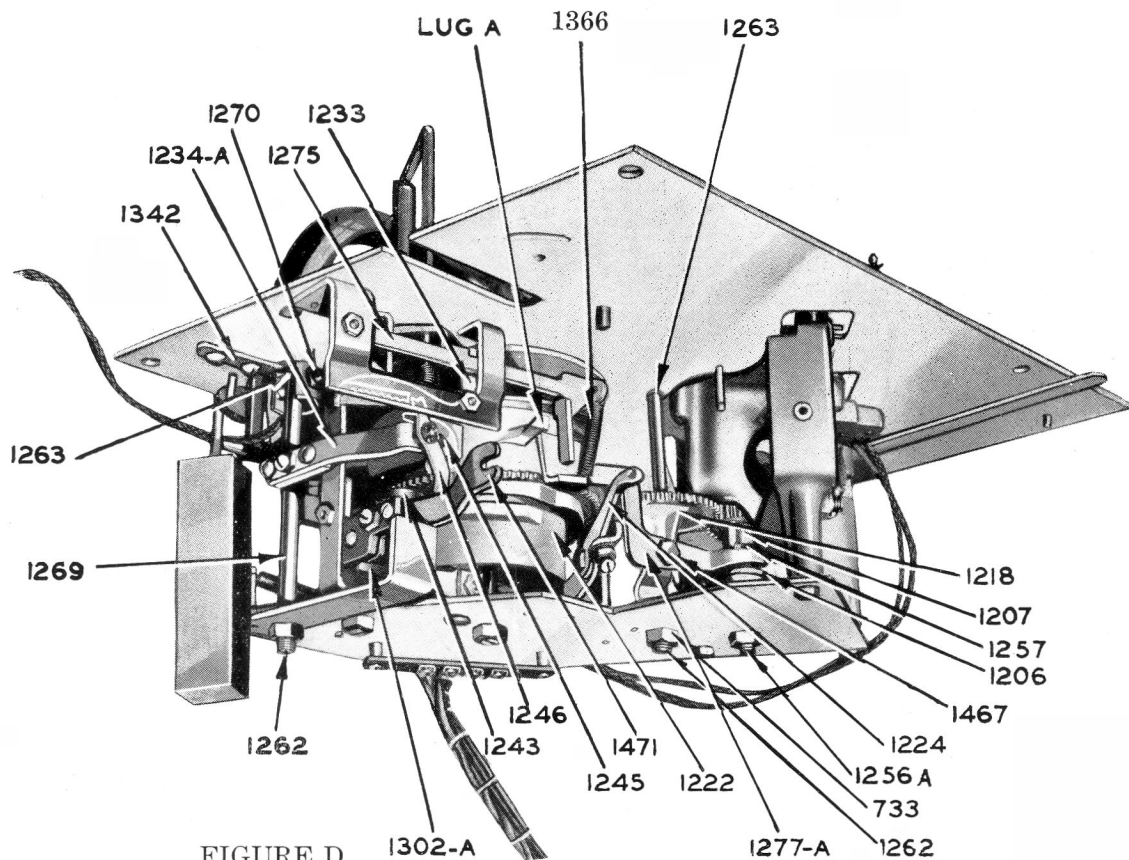
FIGURE D

IF MECHANISM TRIPS HARD, it is probably due to the fact that notch in Trip Lever No. 1233 (Figure D) is not smooth or not machined at the correct angle. Also, it may be due to the fact that Spring No. 1366 (Figure D) has too much tension. A new spring has been designed which has less tension. All springs of the heavier type should be changed to the later design. Throw-out Lever No. 1275 (Figure D) should just rise high enough when Lug A is passing under it to allow notch in Trip Lever No. 1233 to enter under step in Throw-out Lever No. 1275.

IF NEEDLE FAILS TO SLIDE FROM THE SMOOTH PART OF RECORD into the grooves it is probably due to the Pickup Arm being tight or not properly adjusted. Bracket No. 1269 (Figure D) should be tilted toward the discard compartment at top, which gives a natural tendency for Pickup to swing toward the center of record. This can be effected by loosening screws which hold Top Bearing Plate No. 1342 (Figure C) and moving Plate No. 1342 to the proper position. If Pickup Arm is then out of center with the hole, it can be re-adjusted by Pivot Screws No. 1270.

3. Discards records when half through playing?

TO ADJUST CLUTCH LEVER No. 1277-A (Figure D), loosen Stud No. 1467, which is in a slot on Bracket No. 1224, until upper end of Clutch Lever clears Lug A by about 1/32" when Clutch Spool is up as far as it will go, and when mechanism is in the position shown on Figure D. If Clutch rattles or fails to operate properly, it is due to this adjustment. It is possible to change this adjustment by bending lever in some cases, where Stud No. 1467 (Figure D) is not in a slot. However, it is better not to try bending the lever unless mechanism is giving trouble.

Shorten trip lever (Part No. 1233, Figure D) at rear end, so that it is 3/16" long from the bend. This can be done by removing and filing. Or obtain new part from factory.

18. Clutch (Part No. 1206) will not engage ?
Bend clutch lever (Part No. 1277-A, Figure D) so that it will engage in pinion gear (Part No. 1207) and so that end will just clear lug on cam (Part No. 1222) when clutch is in its furthest position. If this raises throw out lever too high when cocking, file off portion of throw out lever (Part No. 1275) which rests on clutch lever (Part No. 1277) until it releases clutch in "STOP" position.
