Electrohome Series 550

Alignment & Adjustment Information

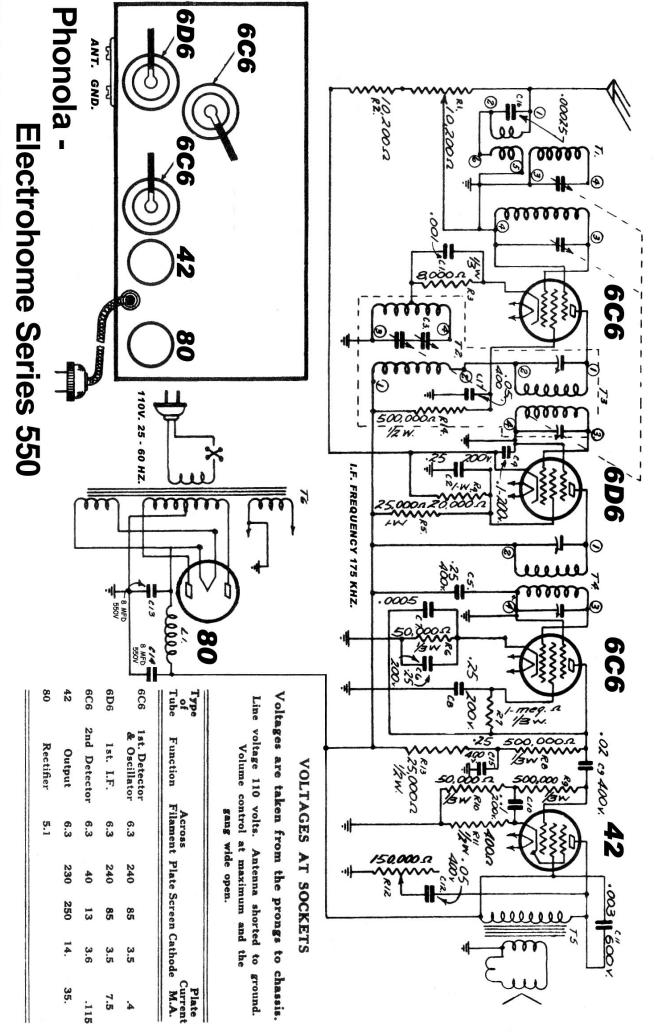
CONDENSER ALIGNMENT

Misalignment or mistracking of condensers generally manifests itself in broad tuning and lack of volume at portions of all of the broadcast band. The receivers are all properly aligned at the factory with precision instruments and realignment should not be attempted unless all other possible causes of the faulty operation have first been investigated and unless the service technician has the proper equipment. A signal generator that will provide an accurately calibrated signals over the broadcast band, and an output indicating meter are necessary. The procedure is as follows:—

Set the signal generator for 175 K.C. Always use the lowest possible signal input in order to secure sharp tuning. Connect the output lead of the signal generator to the grid of the 1st. detector tube through a .05 mfd. condenser. Turn the tuning condenser rotor until the plates are completely out. The ground lead from the signal generator goes to the ground lead of the receiver. Then adjust the four intermediate frequency condensers for maximum output. The adjusting screws for these condensers are accessible from the rear of the chassis.

Next set the signal generator for a signal of exactly 1400 K.C. The output lead of the signal generator is, in this instance, connected to the antenna lead of the receiver. Set the dial pointer on the 1400 K.C. mark on the dial scale and adjust the three trimmer condensers on the gang tuning condenser for maximum output, adjusting the oscillator trimmer first.

Next set the signal generator for a signal of 600 K.C. and adjust the oscillator 600 K.C. trimmer. The adjusting screw for this condenser is accessible from the rear right hand side of the chassis.
