CLAIRTONE SOUND CORPORATION LIMITED  
Toronto New York Chicago Los Angeles

Ref: SB-3-3A

Model: C-303  
C-403

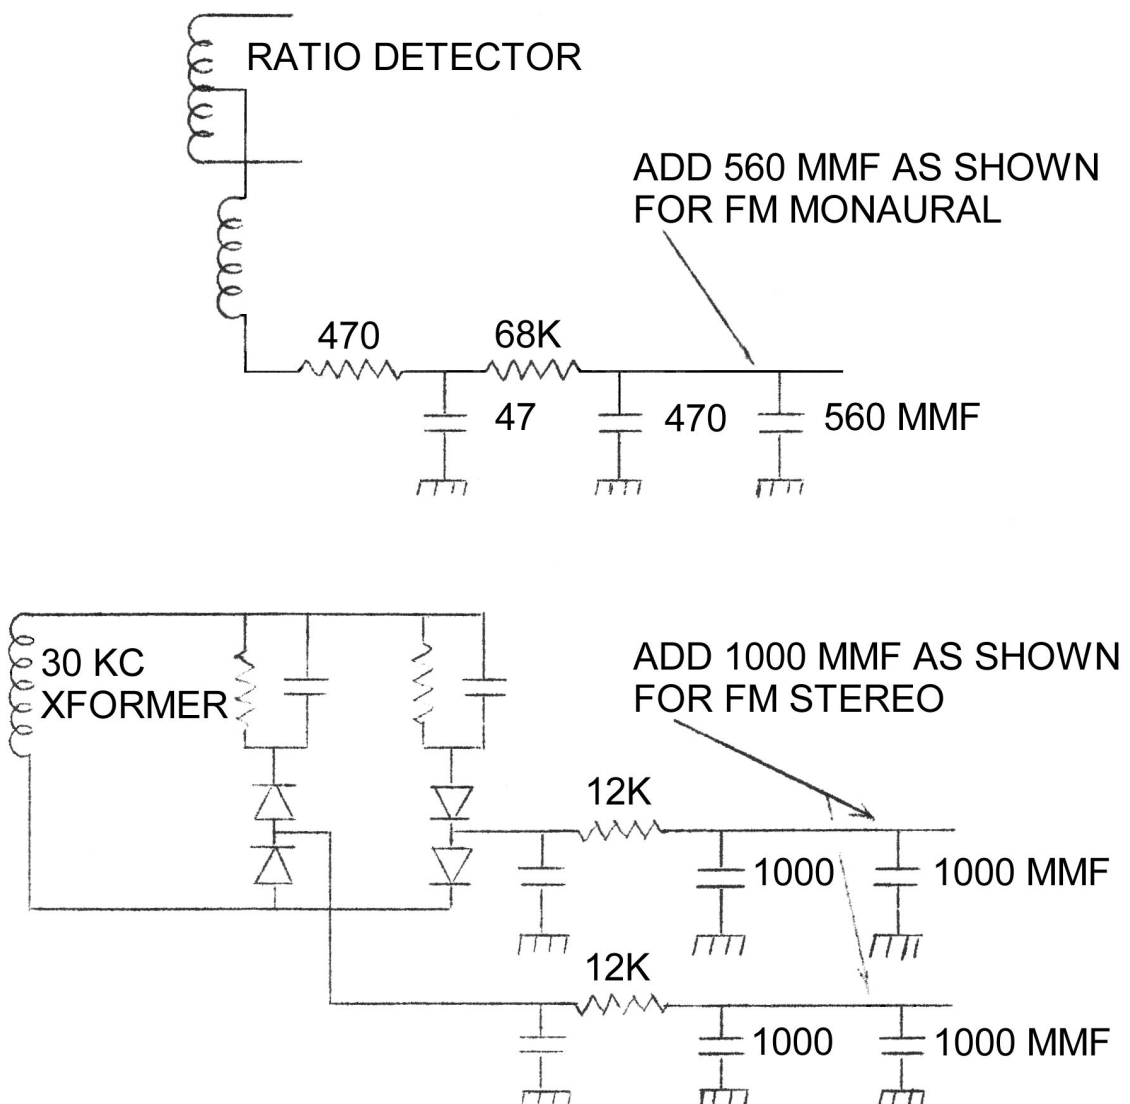
You may receive complaints from various customers on high frequency hiss on FM stereo, and outlined below are the field fix modifications which should be performed in order to satisfy these customers.

Modification: Increase de-emphasis by adding capacitors as shown in the diagram below. Both the 560 mmf and 1000 mmf capacitors should be added.
