Model CV-12 A.C. Power Unit

TECHNICAL INFORMATION AND SERVICE DATA

SERVICE DIVISION . RCA VICTOR COMPANY LIMITED . MONTREAL.

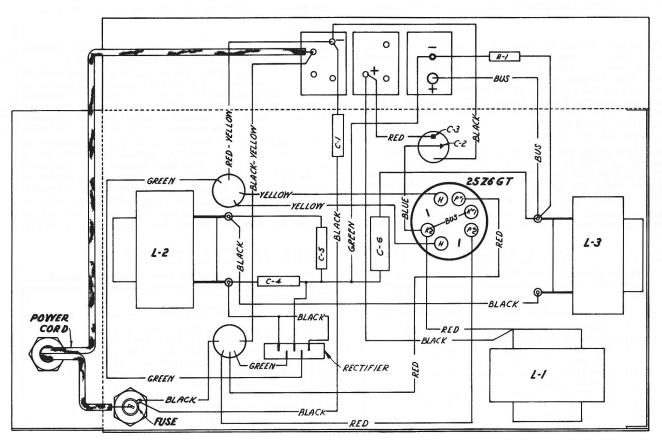
Fig. 2-Chassis Wiring Diagram.

IMPORTANT. If the Power unit is used with a receiver having more than 5 tubes it will be necessary

to remove the Brown-Green-Black (15 ohm) resistor shown in diagram Fig. 2 designated as R-1.
